# Manhole Inspection Summary

Manhole # S31I11005MH

Insp Date: **3/20/07 2:18 PM**

**Location** Address: **31 WARRENTON RD**

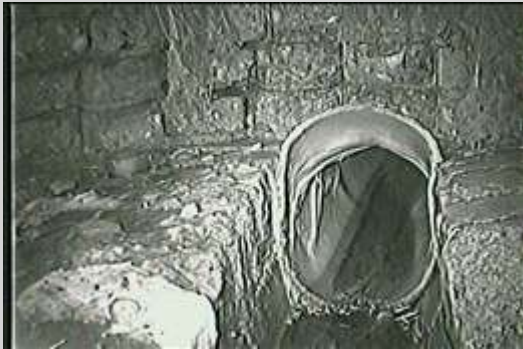
### 8 in. Circular Gravity Sewer Pipe Out @ 12 O'Clock

Pipe Material: **Unknown** ☒ Pipe Lined

Invert Depth: **12.47** (ft.) Flow Characteristics: **Slow**

Infiltration: **None** Pipe Seal Cond: **Unknown**

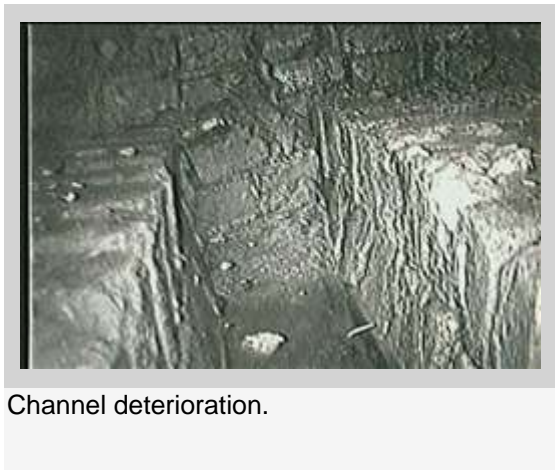
Pipe In @ 6 O'Clock

Pipe Material: ☐ Pipe Lined  
Invert Depth: (ft.) Flow Characteristics: **None**  
Deposits: ☒ None ☐ Mud ☐ Sludge ☐ Debris ☐ Grease  
Silt Depth: (in.) Deposits Extent:  
Infiltration: **None** Pipe Seal Cond: **Unknown**
